U.S. Army Corps of Engineers
Cerro Grande Fire
Flood Fight Plan
San Ildefonso Index

U.S. Army Corps of Engineers
Cerro Grande Fire
Flood Fight Plan
SI -1,-4, -5, -6, -10, -11

U.S. Army Corps of Engineers
Cerro Grande Fire
Flood Fight Plan
SI-2

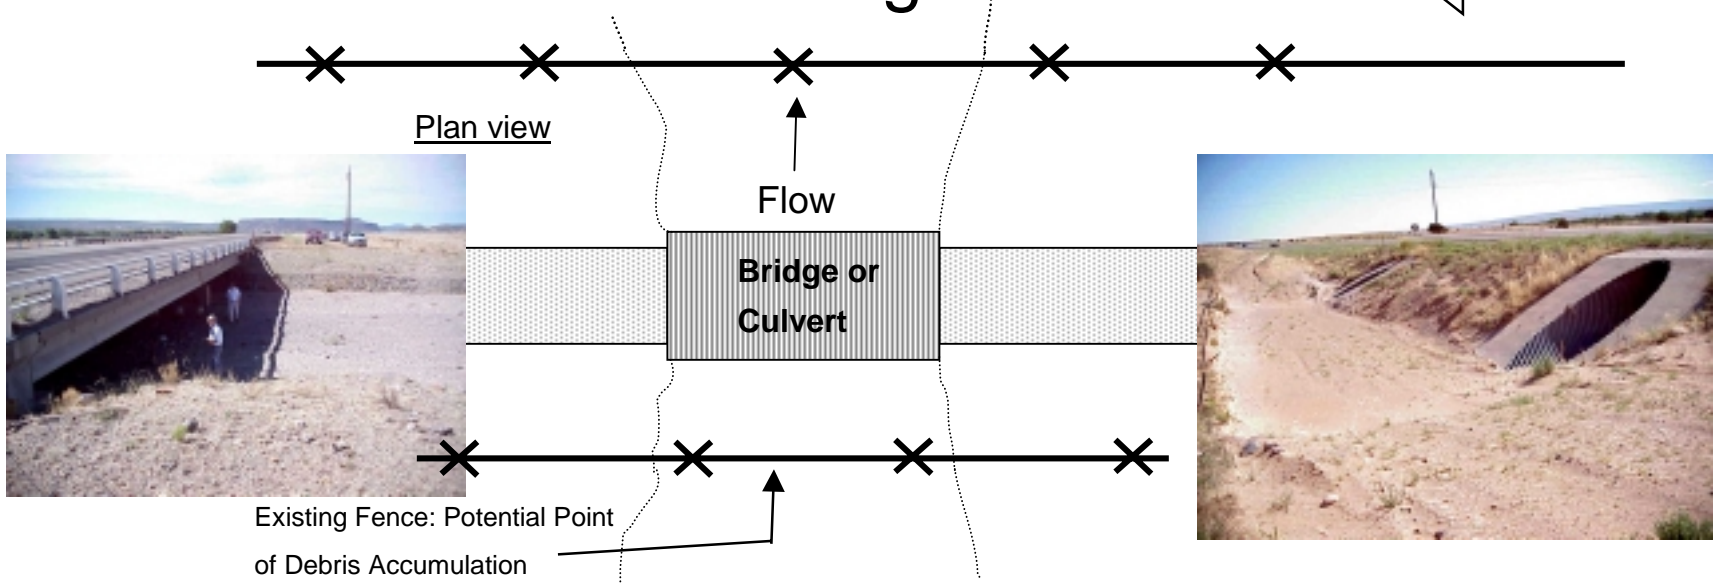
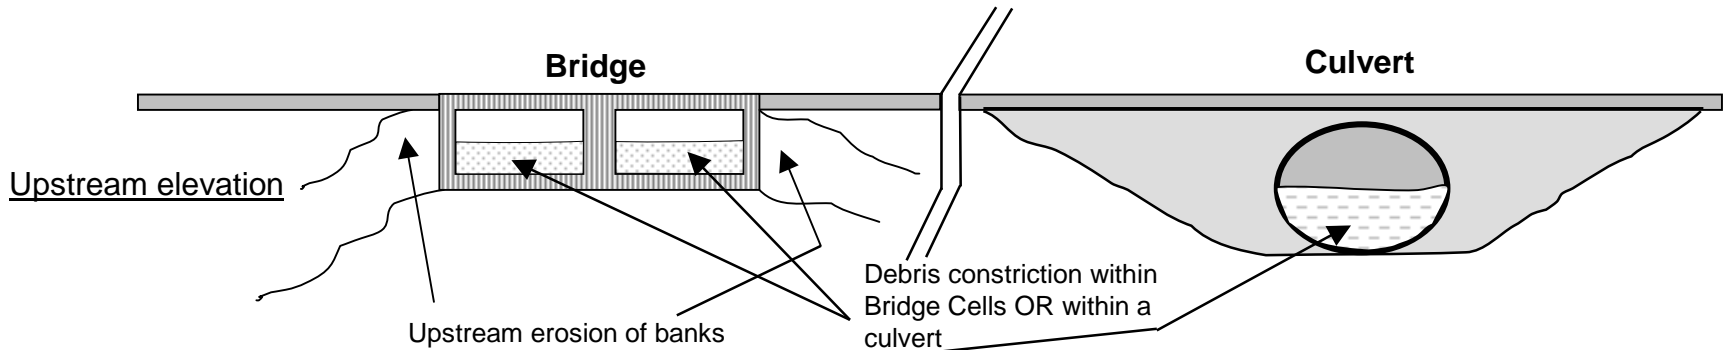
Typical drainage structures

Note: Drainage structure can be either Box culvert or CMP

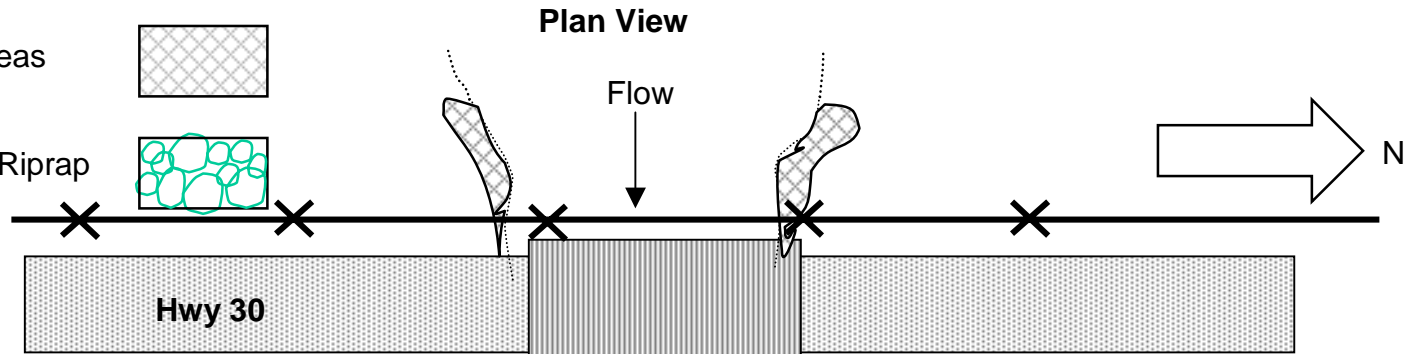
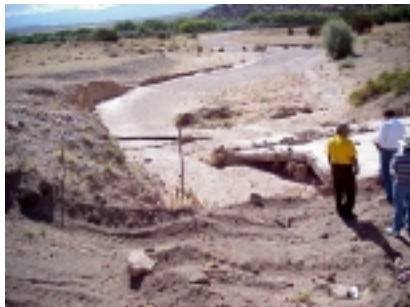
Sandbag around gas line until it can be fixed

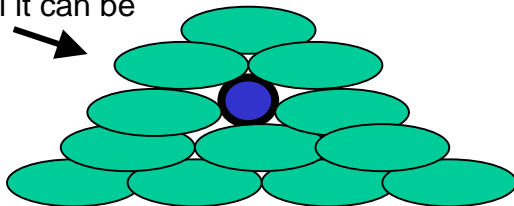
Pipe cross-section

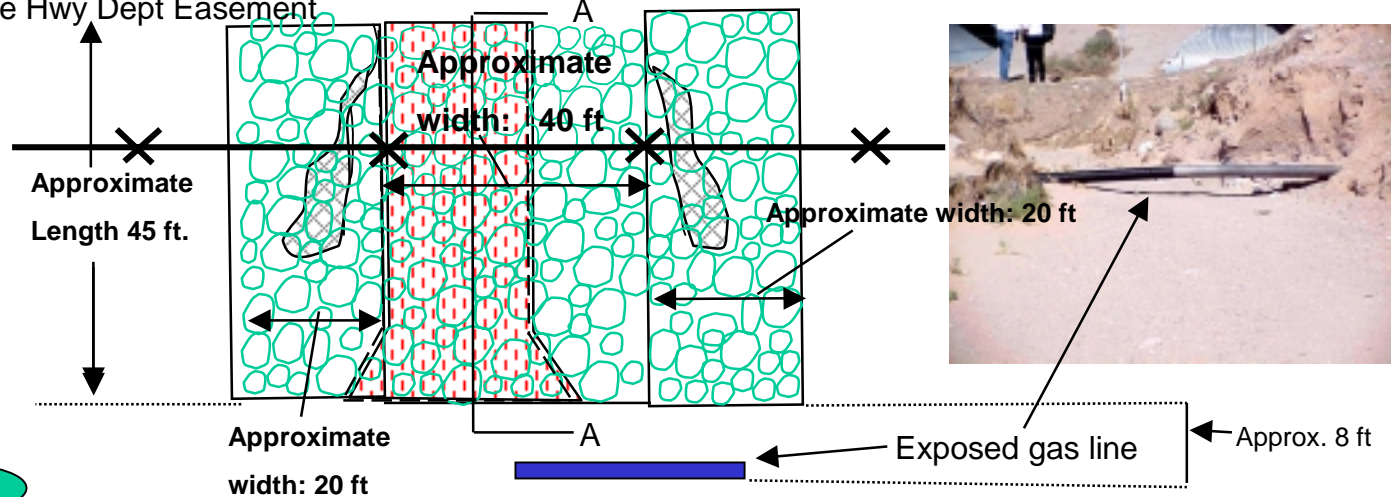
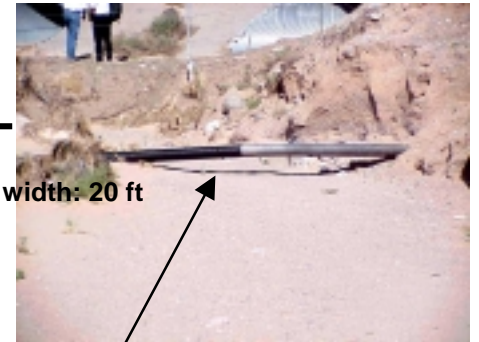
Exposed gas line in San Ildefonso northern boundary wash

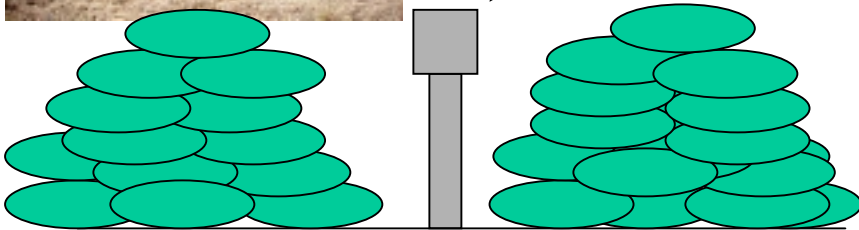
Cross-section

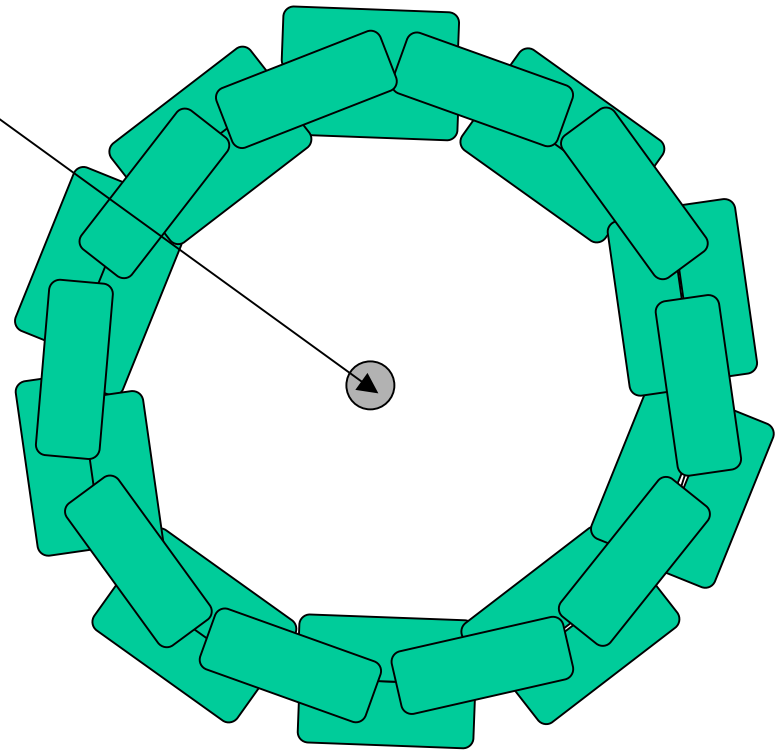
Sandbag ring protection

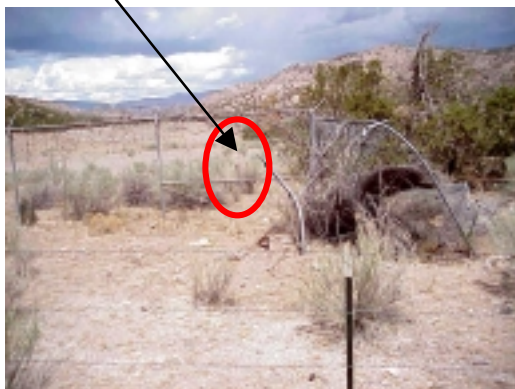
Typical Sandbag protection
around well heads

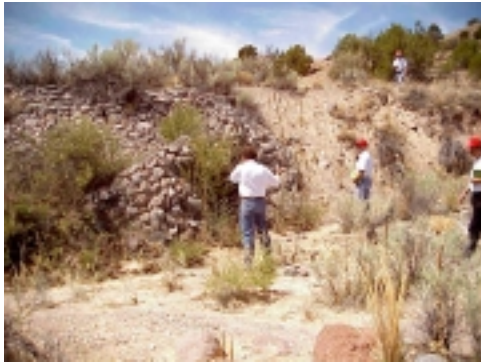
Failure of left bank protection

Riprap mattress failure, right and left banks about 2/3 of the way up levee from bridge

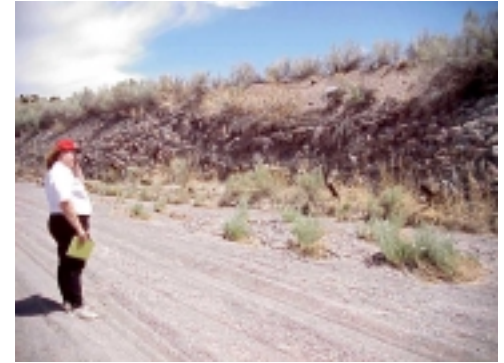
Failure of right bank protection

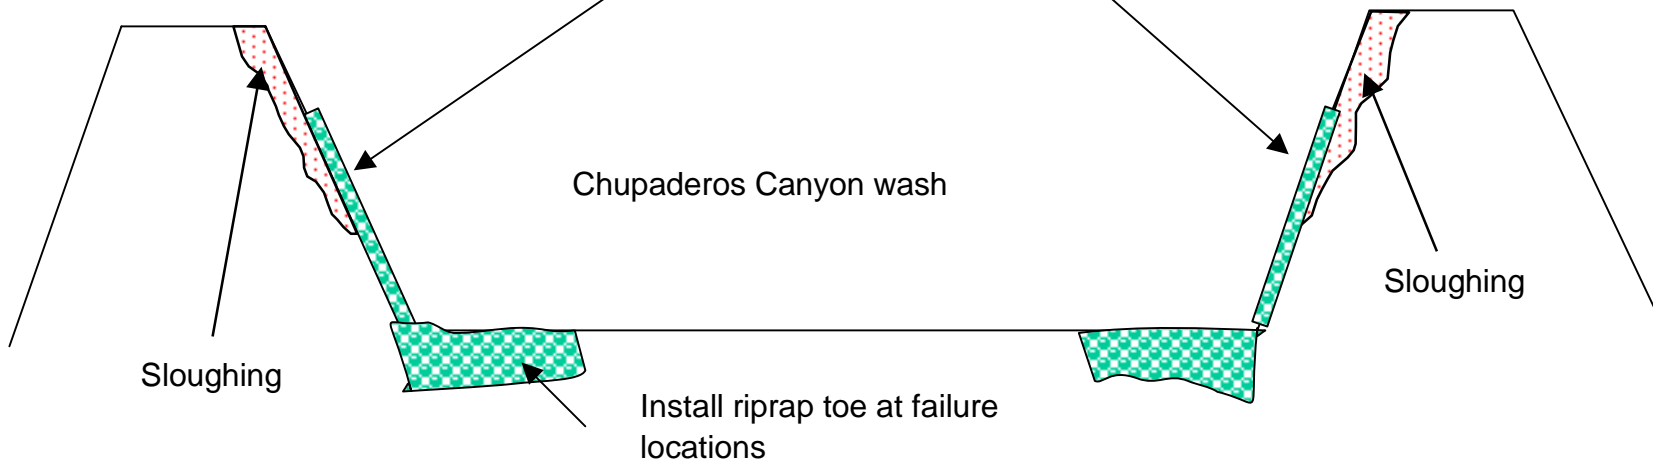
Elevation looking upstream
